SAMPOONG DEPARTMENT STORE COLLAPSE

Alex ANDERSEN, Donald GRIMMER, Keanah LAGAZO

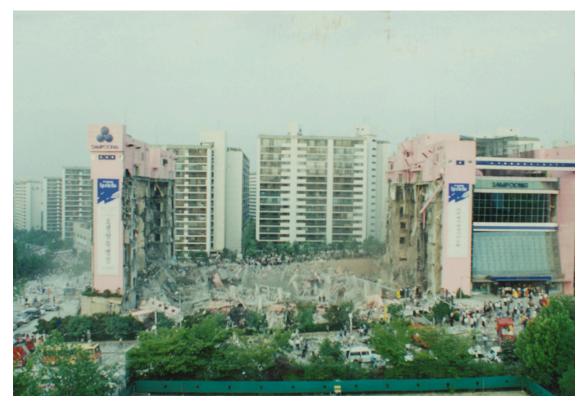
The Sampoong Department Store collapse is one of the most catastrophic failures in modern history. This five-story, reinforced concrete building completely collapsed, resulting in over 500 deaths and many more injured. The store was completed in 1989 and was in service for 5 years before the devastating collapse. In April of 1995, noticeable cracks in the slabs began to form in the south wing of the building's fifth floor. The cracks began to expand exponentially in the following months, but no action was taken except the relocation of merchandise from the 5th floor to the basement. On June 29, 1995 at around 5:00 p.m. South Korea Standard Time, the 5th floor began to sag, prompting workers to block customer access to the 4th floor and 5th floors. At around 5:50 pm, a series of cracking and banging sounds came from the 5th floor, and the workers sounded the alarms. At 5:57 the building collapsed as shown in Figure 1.

Figure 1 - Results of Collapse with North Shear Wall (Left) and Central Core (Right) Maintaining Intact

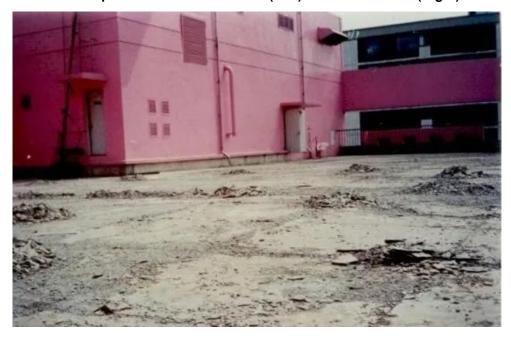
One of the major contributing factors was punching shear failure. Flat slabs are practical in some builds due to the reduced weight they provide to the dead load of a structure. They also require less formwork and are easy to construct. They do however pose a critical analysis problem because the bending moments and shear forces are concentrated at the slab column connection. Punching shear strength in flat slab design is important not only due to the brittle nature of the component, but also because it may induce a progressive collapse through the structure resulting in a stack as seen in Figure 2 and Figure 3. Due to the inadequate slab thickness, steel reinforcement, the failure spread quickly and led to the collapse of the department store. The lack of shear reinforcement further reduced the structure's ability to resist stress concentrations and led to rapid structural failure. There were a number of issues with the slab column configuration. The cover from the top of one of the basement level slabs to the center of the reinforced concrete bar was found to be 150mm instead of 30mm which reduced the bending strength by around 40% of the designed bending strength the slab was intended to support.

Figure 2 - Photo of Punching Shear Taken a Day Before Collapse

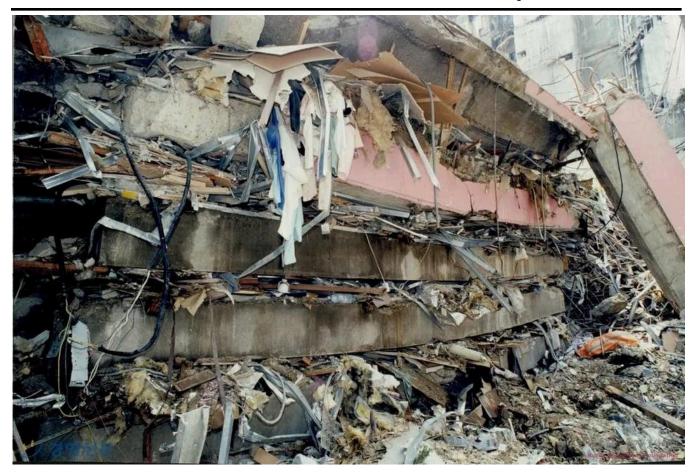
Figure 3 - Aftermath of the Punching Shear Causing Progressive Collapse
